Re: Hanger Hill Gardens Estate

Instruction

F10 Fife Court

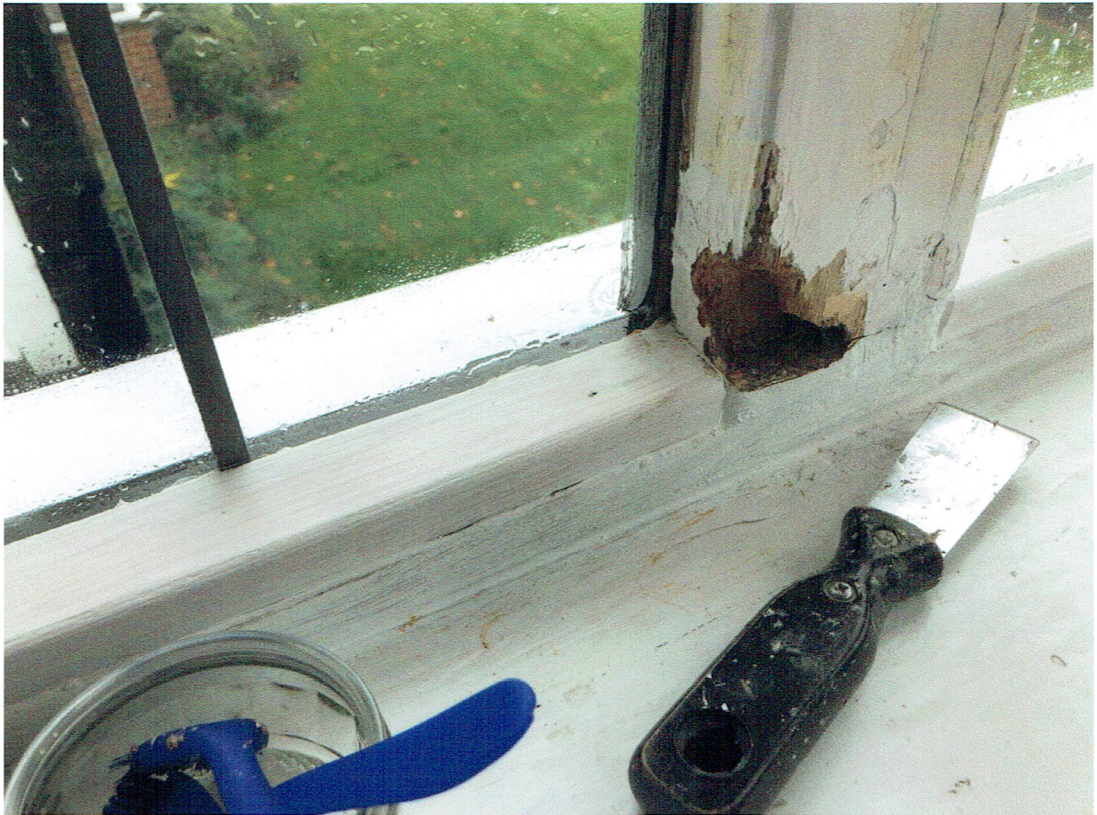
Photo 1

- 2.3 We understand that the work is complete, as far as the contractor is concerned.
- 2.4 The lessee complained that, in beginning to redecorate the interior of the window, she found rot at the base of one of the mullions (see photo 1 below) and she has noticed water ingress coming through under at least one of the new fixed panes, the width of the lead to the new units does not match the original and has concerns that the internal window board slopes considerably towards the outside.

- 3.1 The specification does include for internal repairs to be carried out (where necessary) and clearly, despite the severity of the rot, this has not been done. It also demonstrates the seriousness/extent of the decay and indicates that the cutting back has not been taken far enough.

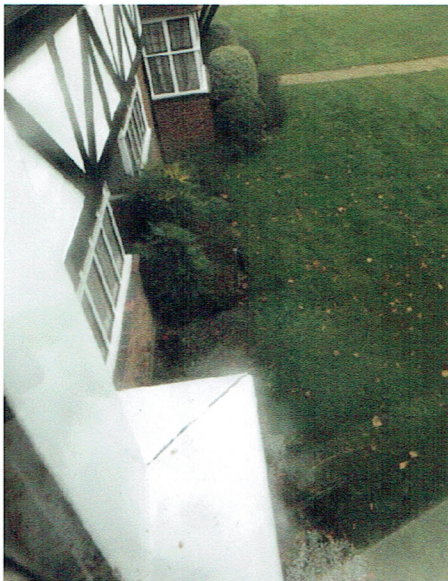
Photo 2

- 3.5 The cill replacement apparently utilises a hardwood (un-known species). The corner mitre joints appear to have been simply butted together and from shrinkage/thermal movement, one of the two joints has opened up. Water ingress over time will cause the cill to decay, at this point, unless rectified. (Photo 2 above)

- 3.6 The mitre joints should be opened up and filled with Repair Care filler.
- 3.7 This cill in question does contain a throat/drip edge although I believe that replacements elsewhere have lacked this essential detail.

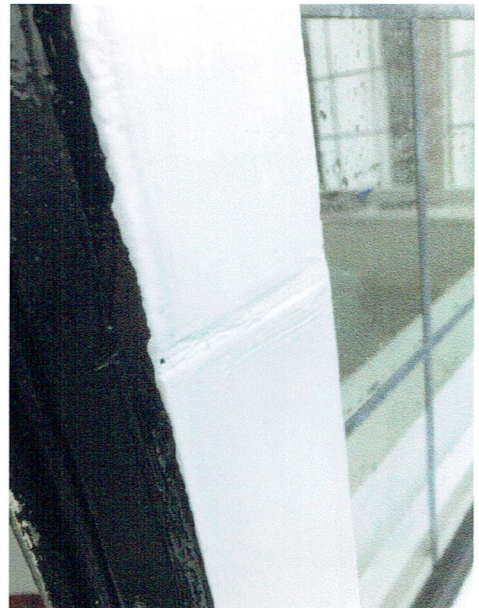
Photo 3

- 3.4 The work carried out to the mullions is a 'cover up'. The specification is 'loose' but notwithstanding, the work is not up to any sort of acceptable standard. The 'splice' joint is very prominent, even from the street and should have been 'lost' in the filling process. (photo 3 above)

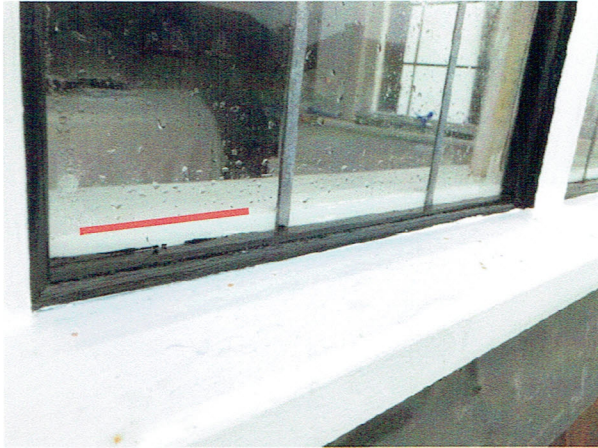
Photo 4

Red line added to indicate top of internal frame, due to lack of step in cill

- 3.9 One issue with the replacement cill is that its profile does not match what seems to be the original which contains a step. This results in the bottom bead not covering the inside bead which is clearly visible through the glass. (photo 4 above)

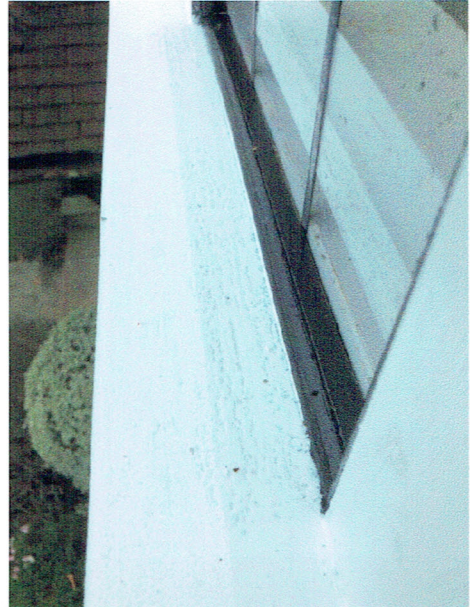
Photo 5

- 3.13 We have not had the advantage of seeing how the woodwork generally has been prepared and the paint applied, in the course of redecoration. However, looking at the finish, the work appears shoddy and somewhat patchy. (photo 5 above)

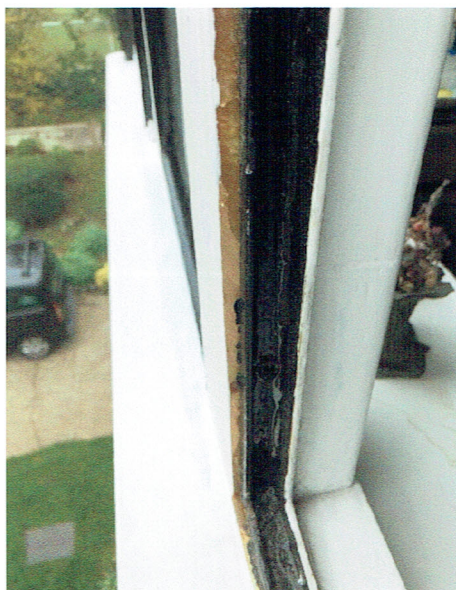
Photo 6

- 4.1 A number of windows were inspected, primarily those to the Master (rear side) bedroom, bathroom and Dining (front) room. Although repair works were apparently undertaken many months ago, decoration is still to be completed.
- 4.2 Master (Rear/side) bedroom - the lessee thought that the cill had not been replaced in this current contract and that internal splicing was from a previous contract. It appears that the external mullions have been re-faced.

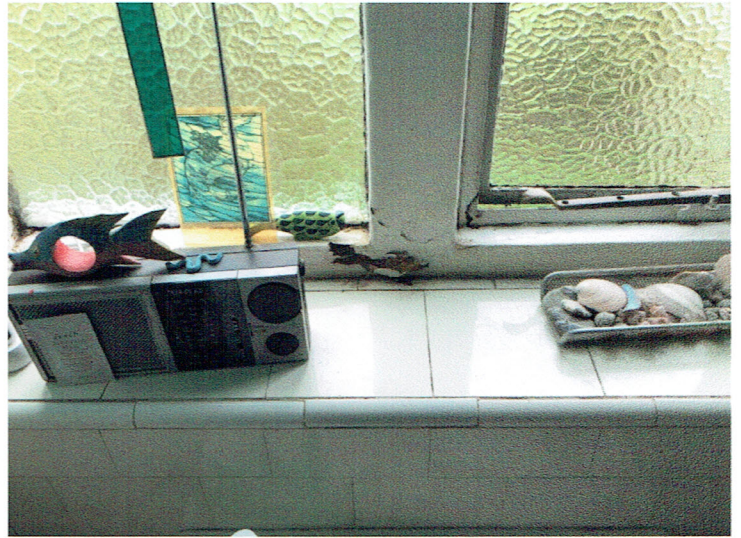
Photo 9

- 4.5 Bathroom – The base of the frame is decayed to such an extent that filler has been forced through past the inside face of the frame. This suggests that far more extensive work is required that appears to have been undertaken.(photo 9)
- 4.6 Again the decorative finish is very poor.
- 4.7 Dining (front) room – The front window has had a new cill fitted and a number of beads replaced (we are informed between 3-6 August this year) and apart from some superficial clear sealant, has not been touched since and is still open to the elements. All replacement woodwork should have been fitted ready primed, at the very least.
- 4.8 There is decayed wood on the inside of the frame which has not been tackled. Where beading has been fitted, a mastic type seal has been applied but in places this has pulled away leaving an entry route for water penetration.(photo 10)

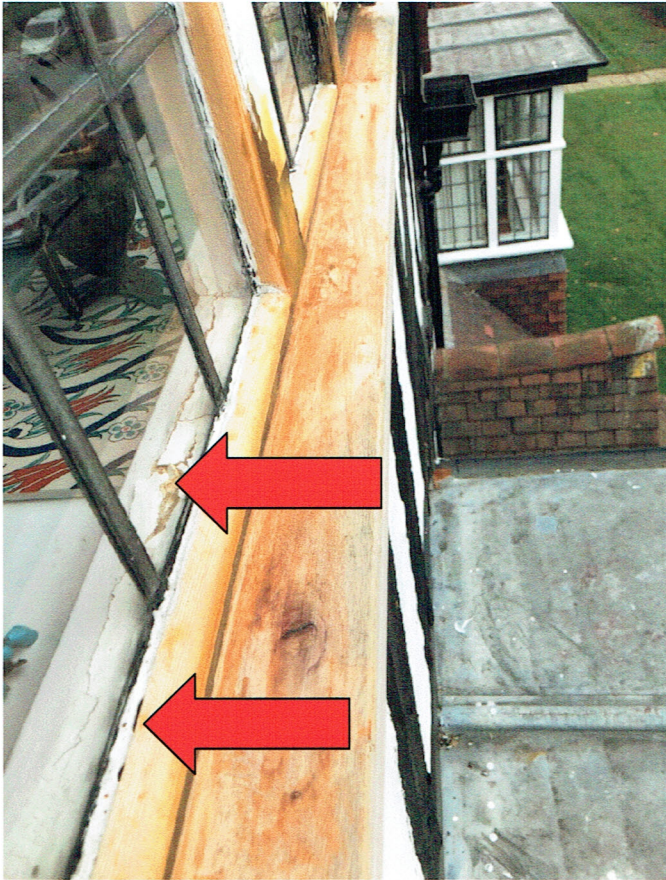
Photo 10

Top arrow shows decay internally,
lower arrow shows mastic having pulled away
